Hazardous Walking Site Review Checklist

Hazardous Walking Site Review - Documentation and Authorization

Hazard Location: Oswalt Road just east of Lakeshore Drive

FDOT HWC# 110021

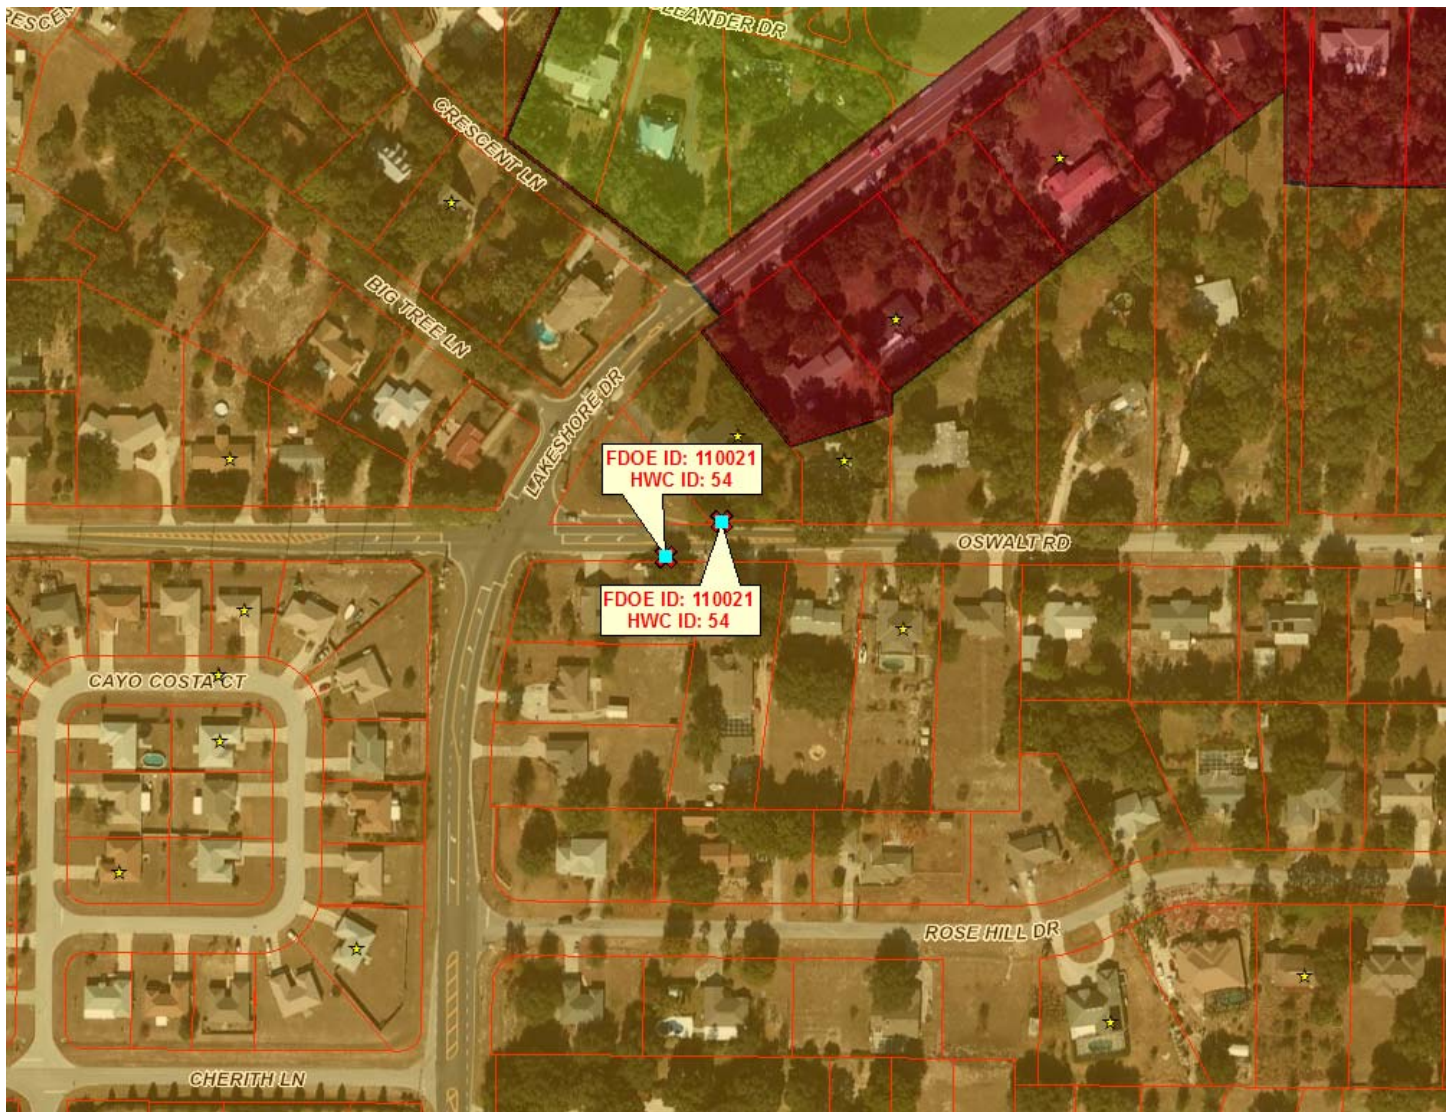
Station Name:2015_LC#210_Oswalt Road
 Site ID:000000000K15
 Station Num:000000000000
 Description:LC#210 Oswalt Rd
 City:
 County:Lake
 Start Date/Time:04-08-2015 00:00
 End Date/Time:04-09-2015 00:00

04-08-2015		Lane 1 (East)												
End Time	00	01	02	03	04	05	06	07	08	09	10	11		
15	6	6	1	0	0	2	2	4	28	24	15	25		
30	2	1	4	2	0	0	0	12	37	18	40	38		
45	3	5	2	2	2	3	6	10	14	16	32	21		
00	4	1	0	2	2	1	8	17	12	15	31	28		
Hr Total	15	13	7	6	4	6	16	43	91	73	118	112		
End Time	12	13	14	15	16	17	18	19	20	21	22	23		
15	33	29	30	35	43	60	62	43	44	33	18	16		
30	24	29	49	41	48	64	68	58	29	30	14	12		
45	38	31	42	50	52	67	59	39	32	15	21	15		
00	27	29	32	39	60	70	51	31	34	14	16	7		
Hr Total	122	118	153	165	203	261	240	171	139	92	69	50		
24 Hour Total :			2287											
AM Peak Hour Begins :			10:15			AM Peak Volume :			128			AM Peak Hour Factor :		0.80
PM Peak Hour Begins :			17:30			PM Peak Volume :			267			PM Peak Hour Factor :		0.95
04-08-2015		Lane 2 (West)												
End Time	00	01	02	03	04	05	06	07	08	09	10	11		
15	1	2	0	1	6	17	36	62	83	47	31	43		
30	4	0	1	0	3	8	47	69	62	40	32	31		
45	2	2	1	3	5	26	54	88	49	42	43	25
